**Flood Control Project Maintenance
Levee Inspections**
LMA District Cover Sheet
Spring 2020 Levee Inspection Results

Lake County Watershed Protection District

Spring 2020 Levee Inspection Results

Waterway			Bank	Unit Miles
Unit No. 01 Middle Creek			Left	3.35
	Spring (March - May)	Summer (June - August)	(September - November) Fall	Winter (December - February)
Unit Maintenance Rating (Fall Only)				
Date of Inspection	4/1/2020 - 4/2/2020			
DWR Inspector	Luz Dial			
Accompanied By	Yuliya Osetrova Lake County

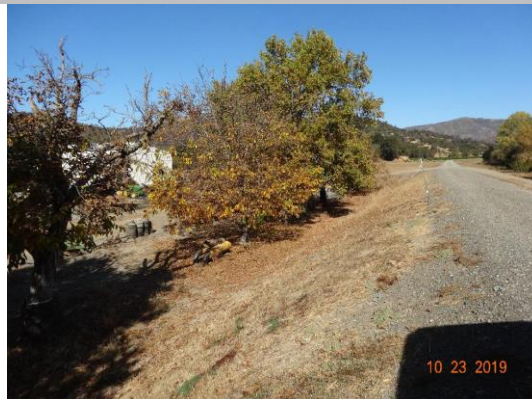
Photo 3 of 3 : UCIP_SP_2020_55865_82644.jpg

LS view: overview of LS.

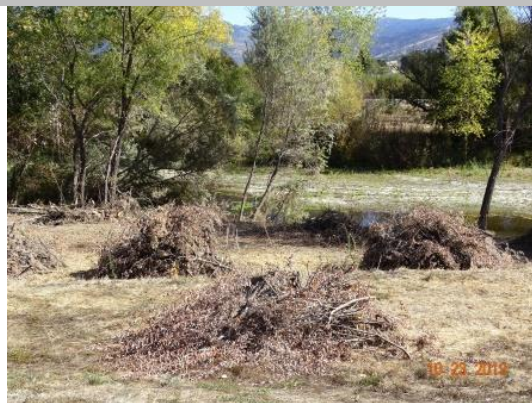
Photo 1 of 1 : SP_2020_NA0009_4_28_20200302_00008.jpg

LM Start	1.95	Rating **	M	Issue No.	28
LM End	1.95	Issue Type +	En	Location *	WS
Category	Earthen Levee			GPS Latitude/Longitude	
				Start	End
Item	Encroachments			39.163548 °	39.163548 °
				-122.916730 °	-122.916730 °
DWR ID	DWR_NA0009_02_f_2019_28				
Comment Code					
PR : Prunings					
Inspector Comment

View of prunings on the waterside berm. Fall 2019

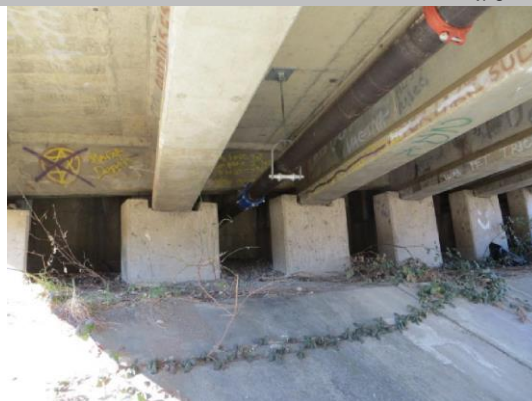
Photo 1 of 3 : UCIP_SP_2020_55752_51263.jpg

Comment Code						
Inspector Comment						
DS_ID:21243 FS_ID:55752 EP_NO: 15865 Repair Type: Non-Urgent Crossing Status: Found UCIP Comments: 10/23/2019 Record remains Non-Urgent, unable to confirm alignment; permit recordation notes pipe was never installed from 1983 to 1999 due to property litigation. 03-10-1999 permit owner requested permit stay active. Recommend auditing permit to confirm if pipe was ever installed. (O. Magana - DWR UCIP)01/22/2014 Permit number likely revised from 15865. Verify with inspector and modify entry as required. (W. Wylie - DWR UCIP) FIELD_STRUCT_DESC: 6-inch polyvinyl chloride pressurized sewer line through the levee, 3 feet below the crown. Cutoff wall around pipe at center of levee. Sanitary Sewer manhole on the waterside (WS) shoulder. (6-inch pipe authorized under Permit No. 15865, 1992 - Zachary Calhoun). FS Date: 10/23/2019 1:19:00 PM

Pipe visible under bridge.

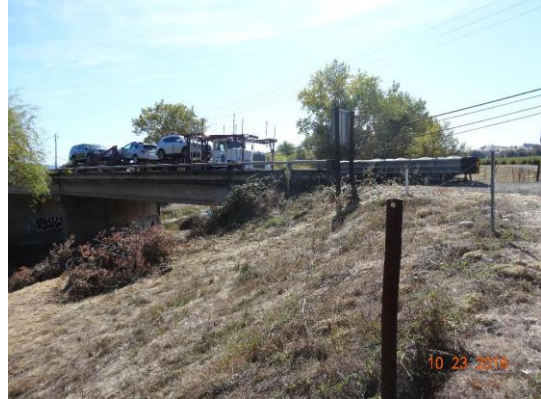
Photo 3 of 3 : UCIP_SP_2020_55752_82685.jpg

WS view: bridge where pipe is suspended from.

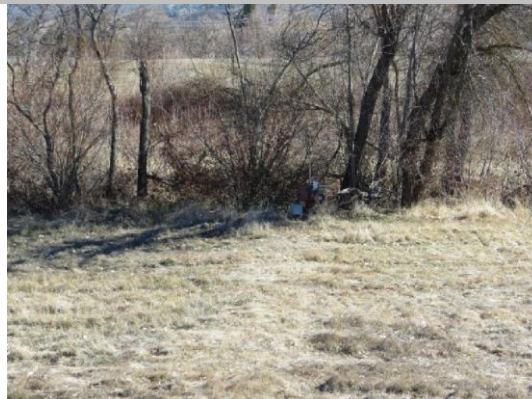
Photo 1 of 3 : UCIP_SP_2020_55753_51274.jpg

Comment Code						
Inspector Comment						
DS_ID:21245 FS_ID:55753 EP_NO: 17191 Repair Type: Non-Urgent Crossing Status: Found UCIP Comments: 10/23/2019 Record has been updated from No Action Needed to Non-Urgent, pipe appears to be abandoned; need to audit record to confirm owner. The UCIP inspection was completed with DWR Inspector, L. Dial, and LMA representative, S. Webb. (O. Magana - DWR UCIP) FIELD_STRUCT_DESC: 1 of 2: 8-inch coated steel irrigation pipe through the levee, 2 feet below the crown. Well and electric pump at the waterside (WS) toe with butterfly valve. (8-inch pipe and conduit authorized under Permit No. 17191, 2000 - Lake County Land and Cattle, LLC). FS Date: 10/23/2019 1:20:00 PM

Pump and pipe on WS berm.

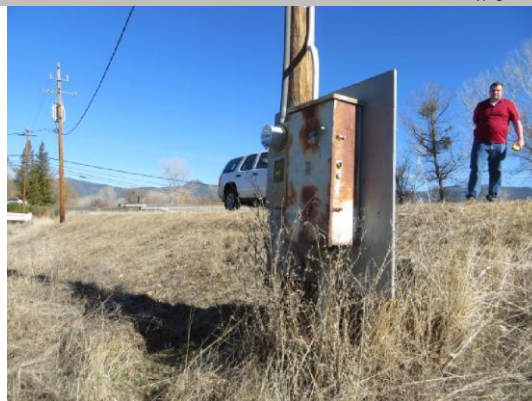
Photo 2 of 3 : UCIP_SP_2020_55755_51279.jpg

Meter and control on LS slope next to pole.

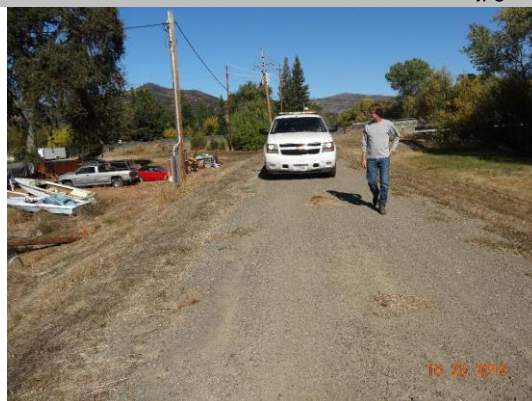
Photo 3 of 3 : UCIP_SP_2020_55755_82708.jpg

Overview of levee crown looking u/s towards pipe crossing.

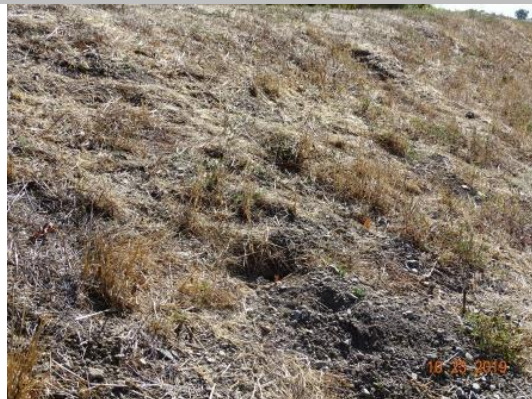
Photo 2 of 2 : SP_2020_NA0009_4_30_20200302_00010.jpg

LM Start	2.01	Rating **	M	Issue No.	30
LM End	2.01	Issue Type +	Ma	Location *	LS
Category	Earthen Levee			GPS Latitude/Longitude	
				Start	End
Item	Animal Control			39.162658 °	39.162658 °
				-122.916875 °	-122.916875 °
DWR ID	DWR_NA0009_02_f_2019_30				
Comment Code					
A3 : No rodents visible, but rodent burrows visible; need to backfill and compact or grout burrows.					
Inspector Comment					
Backfill the rodent holes.

View looking downstream at animal holes on the landside slope with recent activity. Fall 2019

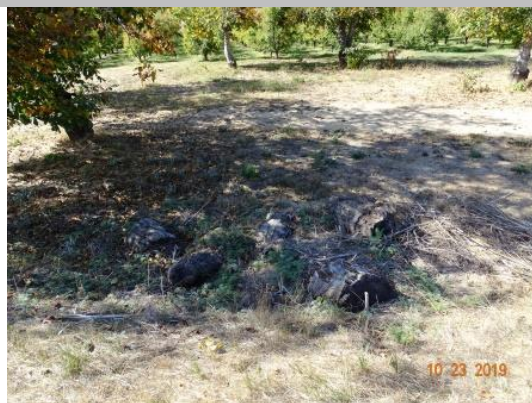
Photo 1 of 1 : SP_2020_NA0009_4_32_20200302_00012.jpg

LM Start	2.76	Rating **	M	Issue No.	32
LM End	2.76	Issue Type +	En	Location *	LS
Category	Earthen Levee			GPS Latitude/Longitude	
				Start	End
Item	Encroachments			39.152425 °	39.152425 °
				-122.915373 °	-122.915373 °
DWR ID	DWR_NA0009_02_f_2019_32				
Comment Code					
TR : Tree or limb					
Inspector Comment					
Instruct landowner to remove tree logs from the levee toe.

View of tree logs at the levee toe. Fall 2019

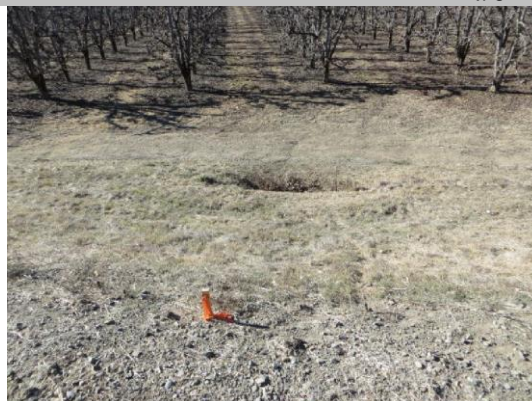
Photo 1 of 3 : UCIP_SP_2020_55756_51283.jpg

Comment Code					
Inspector Comment					
DS_ID:21215 FS_ID:55756 EP_NO: 11481 Repair Type: Non-Urgent Crossing Status: Found UCIP Comments: 10/23/2019 Record remains Non-Urgent; need to audit record to confirm owner. Crossing has been internally inspected under the DWR DMP Phase 1 project. Inspection report is still not available. The UCIP inspection was completed with DWR Inspector, L. Dial, and LMA representative, S. Webb. (O. Magana - DWR UCIP)01/22/2014 Soil partially blocking inlet and outlet. (W. Wylie - DWR UCIP) FIELD_STRUCT_DESC: 24-inch corrugated metal drainage pipe through the levee, 12 feet below the crown. Flap gate on the waterside (WS) end. Concrete headwalls on both ends. (24-inch pipe [HLM 2.93] retained under Automatic Board Order (ABO) issued as Permit No. 11481, 1975 - Dennis P. McCarthy). [Additional Reference(s): DWR Levee Log, 2005. USACE Sacramento O&M Manual 506.2, August 1961, (HLM 2.93), Station M173+00, 24-inch pipe, dwg no. CC-4-4-29, Index Sheet 4: page 4, 38 of 64]. FS Date: 10/23/2019 1:22:00 PM

Concrete headwall and pipe visible at LS toe.

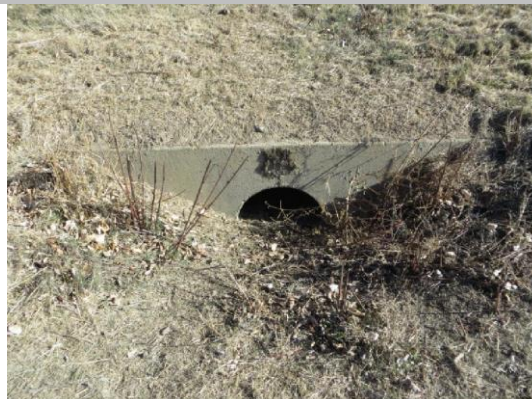
Photo 3 of 3 : UCIP_SP_2020_55756_51281.jpg

Concrete headwall and pipe visible at LS toe.

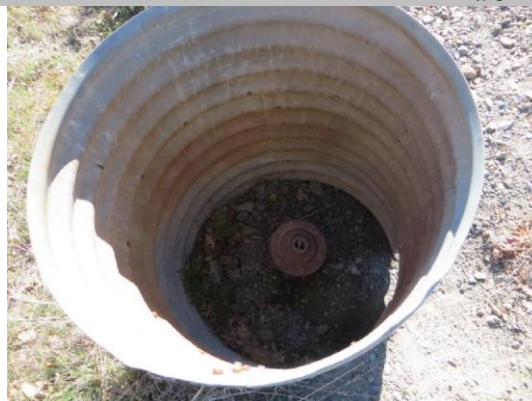
Photo 1 of 3 : UCIP_SP_2020_55768_51522.jpg

DS_ID:21216
 FS_ID:55768
 EP_NO: 11492
 Repair Type: Non-Urgent
 Crossing Status: Found
 UCIP Comments: 10/24/2019 Record has been updated from No Action Needed to Non-Urgent; need to audit record to confirm owner. (O. Magana - DWR UCIP)
 FIELD_STRUCT_DESC: 6-inch steel irrigation pipe through the levee, 2 feet below the crown. Siphon breaker in 24-inch corrugated metal riser unit on the landside (LS) slope. Steel cap on the waterside (WS) berm. 1.5-inch polyvinyl chloride electrical conduit at same location with electrical panel on the LS toe just off to the north. (Pipe retained under Automatic Board Order (ABO) issued as Permit No. 11492, 1975 - Dennis P. McCarthy). [Additional Reference(s): DWR Levee Log, 2005. USACE Sacramento O&M Manual 506.2, August 1961, (HLM 0.41), Station S26+50, 6-inch pipe, dwg no. CC-4-4-29, Index Sheet 4: page 4, 38 of 64].
 FS Date: 10/24/2019 12:25:00 PM

Siphon breaker in 24-inch CMP riser on SL slope.

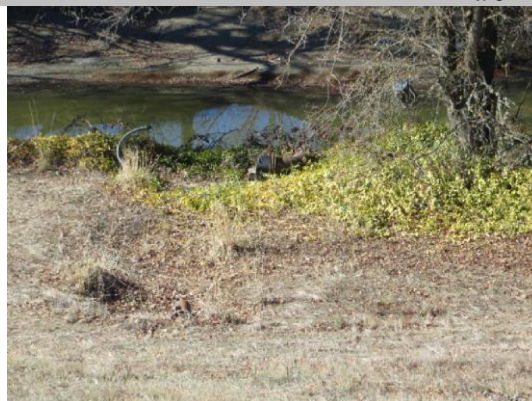
Photo 3 of 3 : UCIP_SP_2020_55768_51520.jpg

Pump mount, pipe, and electrical conduit visible on WS berm.

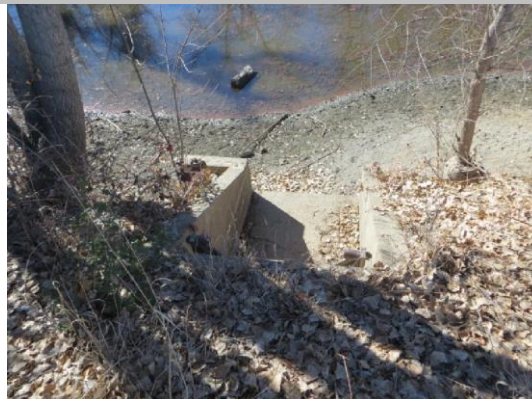
Photo 2 of 3 : UCIP_SP_2020_55769_51541.jpg

Concrete headwall and flapgate visible at WS berm.

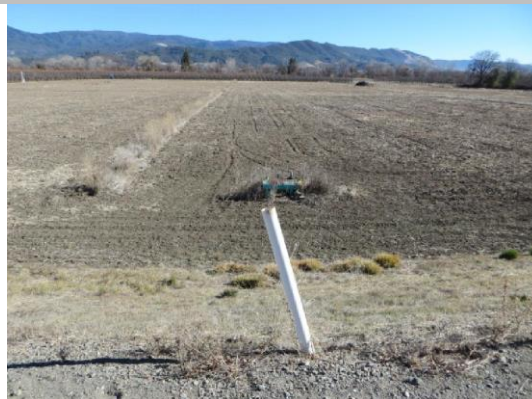
Photo 1 of 3 : UCIP_SP_2020_55770_51562.jpg

Vent on LS shoulder with filter visible off LS toe.

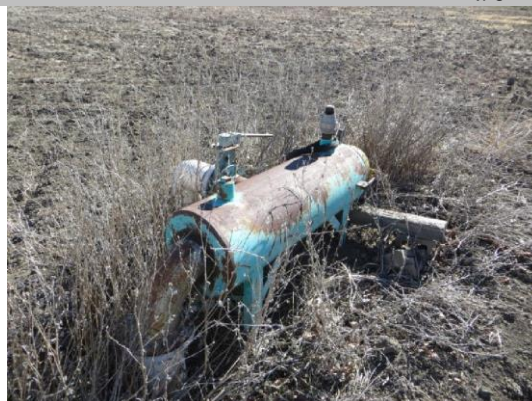
Photo 3 of 3 : UCIP_SP_2020_55770_51560.jpg

Filter, shutoff valve, and vent visible off LS toe.

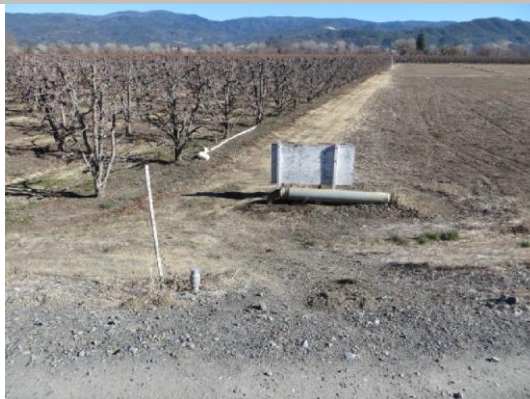
Photo 2 of 3 : UCIP_SP_2020_55767_51581.jpg

Siphon Breaker on LS shoulder with filter and electrical panel visible at LS toe.

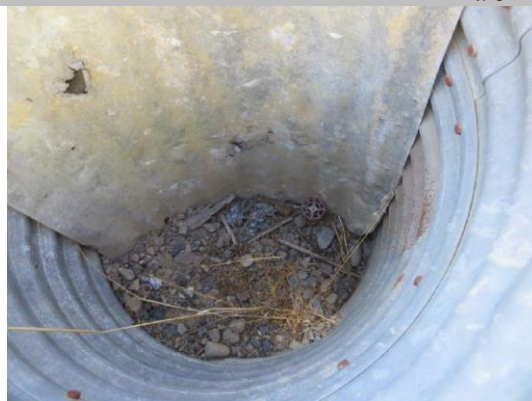
Photo 1 of 3 : UCIP_SP_2020_55775_51587.jpg

Valve visible at bottom of CMP riser on LS shoulder.

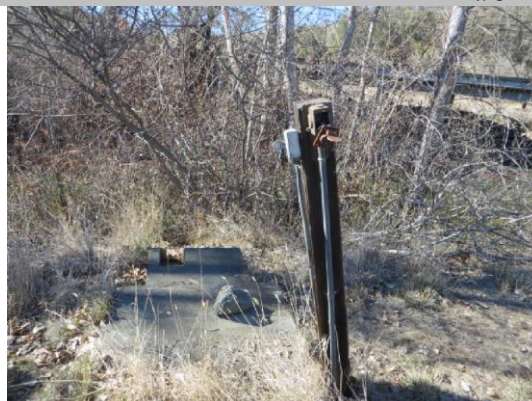
Photo 3 of 3 : UCIP_SP_2020_55775_51585.jpg

Concrete pump pad and electrical works visible on WS berm.

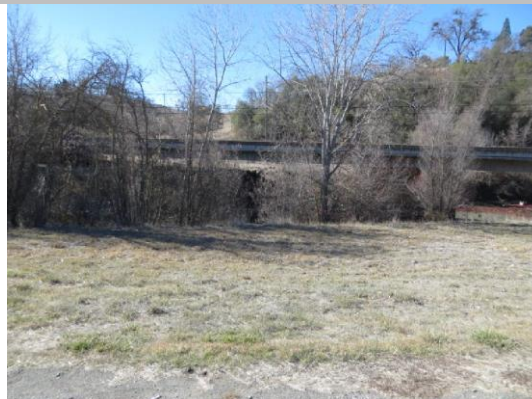
Photo 2 of 3 : UCIP_SP_2020_55778_51590.jpg

Concrete outfall visible off WS berm.

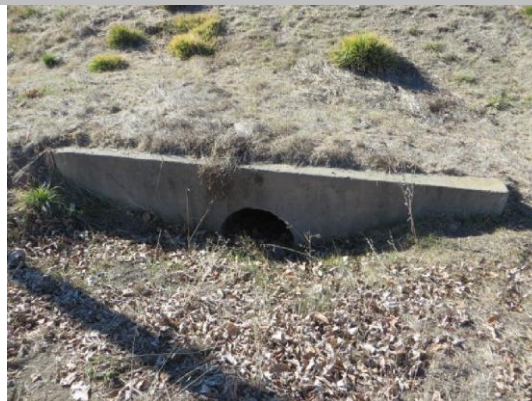
Photo 3 of 3 : UCIP_SP_2020_55778_51589.jpg

Concrete headwall visible at LS toe.

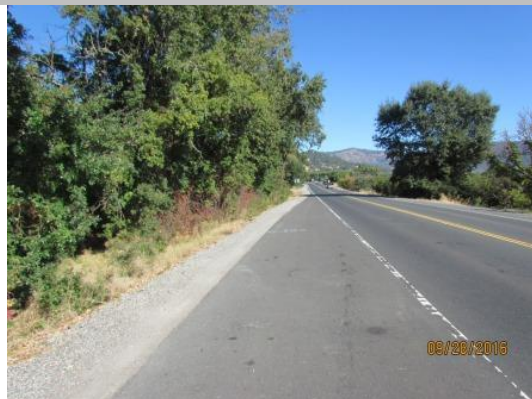
Photo 1 of 1 : SP_2020_NA0009_5_14_20200302_00005.jpg

LM Start	0.84	Rating **	M	Issue No.	14
LM End	0.89	Issue Type +	Ma	Location *	WS
Category	Earthen Levee			GPS Latitude/Longitude	
				Start	End
Item	Trim / Thin Trees			39.158556 °	39.159304 °
				-122.920674 °	-122.920784 °
DWR ID	DWR_NA0009_03_f _ 2016_14				
Comment Code					
T2 : Thin trees to allow visibility of the ground and room to flood fight.					
Inspector Comment

View of the waterside vegetation looking upstream. Fall 2016

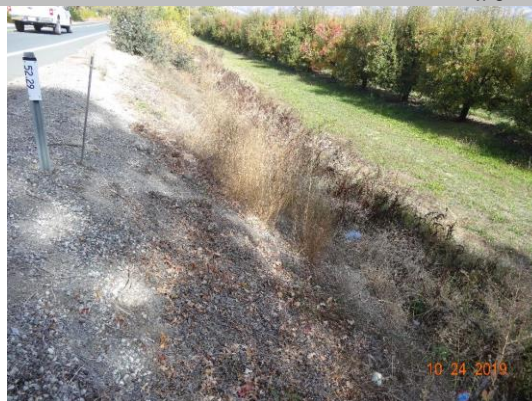
Photo 1 of 3 : UCIP_SP_2020_55781_82827.jpg

LS view: limited access to LS due to steep LS slope.

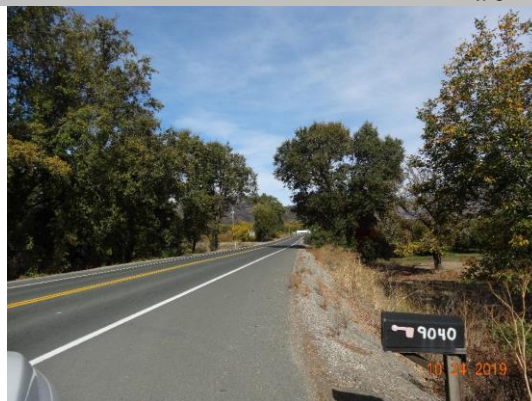
Photo 3 of 3 : UCIP_SP_2020_55781_82825.jpg

Overview of levee/State Route 29 looking u/s towards pipe crossing.

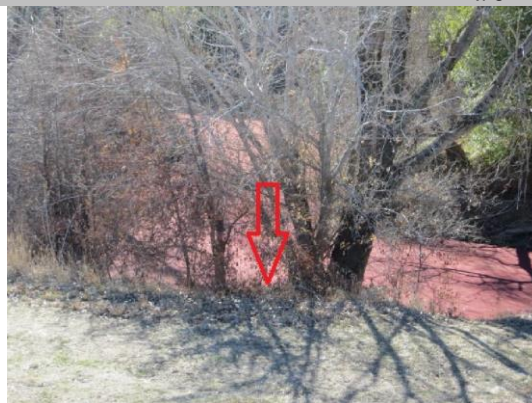
Photo 1 of 3 : UCIP_SP_2020_55782_51599.jpg

DS_ID:21221
 FS_ID:55782
 EP_NO: 11488
 Repair Type: Non-Urgent
 Crossing Status: Found
 UCIP Comments: 10/24/2019 Record remains Non-Urgent due to 2-foot scour under headwall noted in 2014; need to audit record to confirm owner. Crossing has been internally inspected under the DWR DMP Phase 1 project. Inspection report is still not available. (O. Magana - DWR UCIP)01/22/2014 Concrete headwall on WS berm is being undermined. 2-foot of scour under headwall. (W. Wylie - DWR UCIP)
 FIELD_STRUCT_DESC: 42-inch corrugated metal drainage pipe through the levee, 16.5 feet below the crown. Flap gate on the waterside (WS) end. Concrete headwalls on both ends. (42-inch pipe [HLM 0.94] retained under Automatic Board Order (ABO) issued as Permit No. 11488, 1975 - Robert F. and Mary E. Wheeler). [Additional Reference(s): DWR Levee Log, 2005. USACE Sacramento O&M Manual 506.2, August 1961, (HLM 0.94), Station S53+84, 42-inch pipe, dwg no. CC-4-4-29, Index Sheet 4: page 4, 38 of 64].

Flapgate and headwall off WS toe.

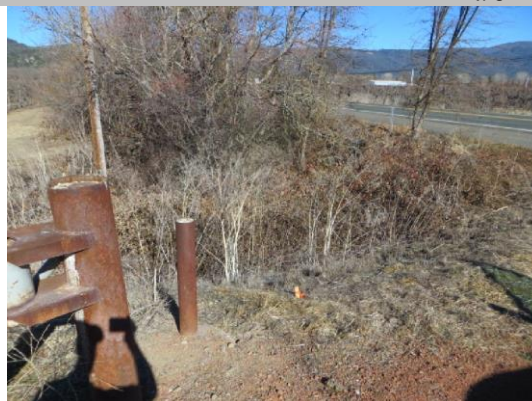
Photo 2 of 3 : UCIP_SP_2020_55782_51598.jpg

Concrete headwall on LS toe.

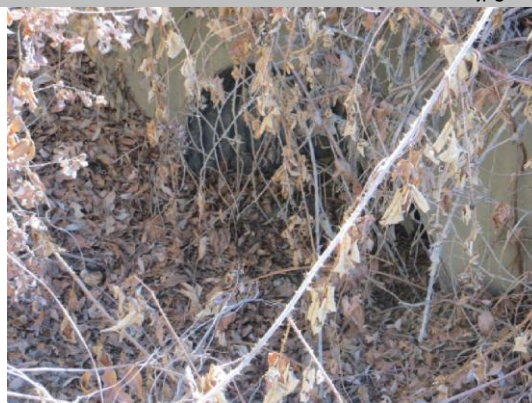
Photo 3 of 3 : UCIP_SP_2020_55782_51597.jpg

Concrete headwall on LS toe.

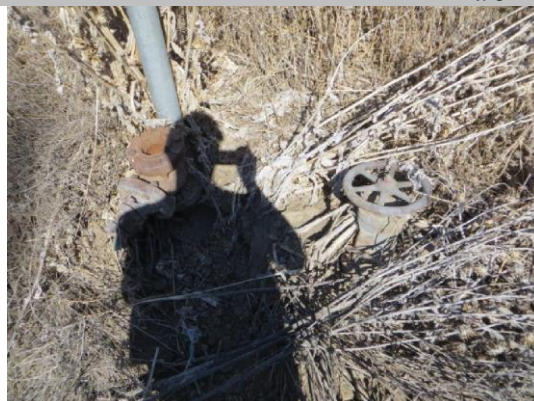
Photo 2 of 3 : UCIP_SP_2020_55783_51621.jpg

Comment Code						
Inspector Comment						
DS_ID:21248 FS_ID:55783 EP_NO: 11488 Repair Type: Non-Urgent Crossing Status: Indicator Found UCIP Comments: 10/24/2019 Record remains Non-Urgent; need to audit record to confirm owner. Pipe and appurtenances appear to have been modified. Need to contact owner to obtain permit authorizing modifications to crossing. (O. Magana - DWR UCIP)01/22/2014 Siphon breaker standpipe knocked over and covered with dirt. Pipe and appurtenances appear to be in disrepair. Gate valves next to tank broken. (W. Wylie - DWR UCIP) FIELD_STRUCT_DESC: 6-inch steel irrigation pipe through the levee, 2.5 feet below the crown. Siphon breaker in 24-inch corrugated metal riser unit on the landside (LS) shoulder. Screw gate on the waterside (WS) slope next to pump and 300-gallon tank. (Pipe retained under Automatic Board Order (ABO) issued as Permit No. 11488, 1975 - Robert F. and Mary E. Wheeler). [Additional Reference(s): USACE Sacramento O&M Manual 506.2, August 1961, (HLM 1.02)]. FS Date: 10/24/2019 12:28:00 PM

Gate valves at tank appear to be in disrepair.

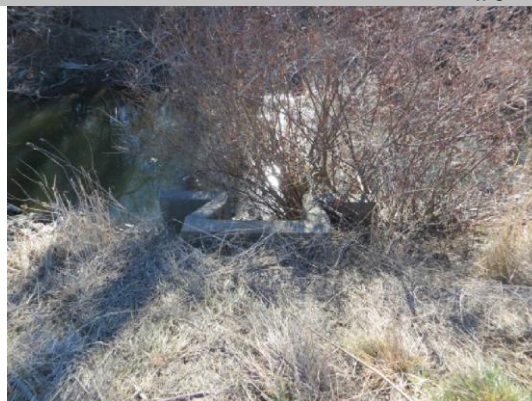
Photo 1 of 3 : UCIP_SP_2020_55784_51642.jpg

DS_ID:21222
FS_ID:55784
EP_NO: 11488
Repair Type: Non-Urgent
Crossing Status: Found
UCIP Comments: 10/24/2019 Record remains Non-Urgent due to scour developing behind d/s wingwall; need to audit record to confirm owner. Crossing has been internally inspected under the DWR DMP Phase 1 project. Inspection report is still not available. (O. Magana - DWR UCIP)01/22/2014 Some vegetation buildup at inlet and outlet. (W. Wylie - DWR UCIP)
FIELD_STRUCT_DESC: 24-inch corrugated metal drainage pipe through the levee, 14 feet below the crown. Flap gate on the waterside (WS) end. Concrete headwalls on both ends. (24-inch pipe [HLM 1.01] retained under Automatic Board Order (ABO) issued as Permit No. 11488, 1975 - Robert F. and Mary E. Wheeler). [Additional Reference(s): DWR Levee Log, 2005. USACE Sacramento O&M Manual 506.2, August 1961, (HLM 1.01), Station S57+06, 24-inch pipe, dwg no. CC-4-4-29, Index Sheet 4: page 4, 38 of 64].

Concrete Headwall on WS berm.

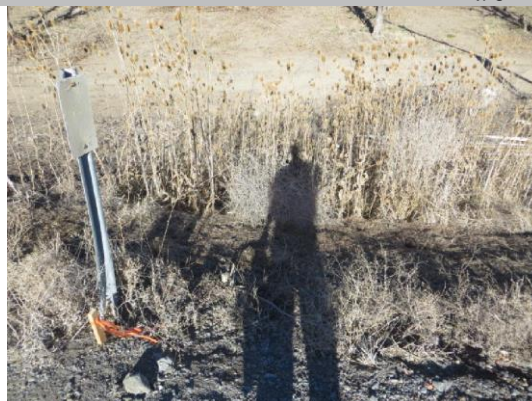
Photo 3 of 3 : UCIP_SP_2020_55784_51640.jpg

Pipe location marked on crown by flasher.

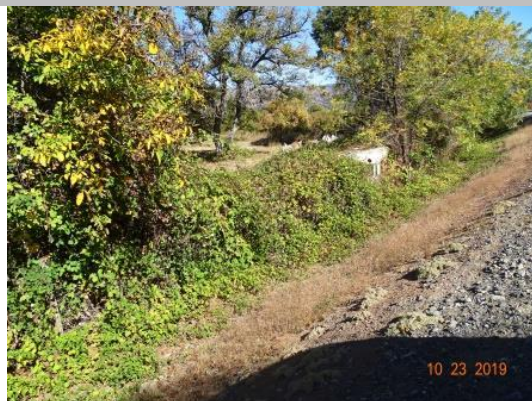
Photo 1 of 2 : SP_2020_NA0009_5_12_20200302_00002.jpg

LM Start	1.01	Rating **	M	Issue No.	12
LM End	1.08	Issue Type +	Ma	Location *	LS
Category	Earthen Levee			GPS Latitude/Longitude	
				Start	End
Item	Vegetation			39.160110 °	39.159707 °
				-122.922458 °	-122.923673 °
DWR ID	DWR_NA0009_03_s_2016_12				
Comment Code					
V2 : Remove the wild growth other than native grasses from the levee slopes.					
Inspector Comment					
The LMA removed most of the growth except for the remainder on the fence.

View of vines covering the fence along the landside toe. Fall 2019

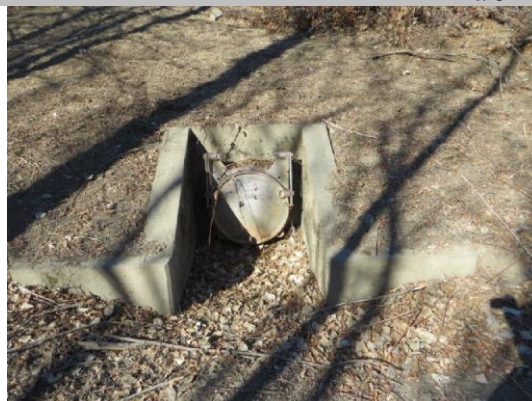
Photo 2 of 3 : UCIP_SP_2020_55785_51645.jpg

Comment Code						
Inspector Comment						
DS_ID:21223 FS_ID:55785 EP_NO: 11489 Repair Type: Non-Urgent Crossing Status: Found UCIP Comments: 10/24/2019 Record remains Non-Urgent; need to audit record to confirm owner. Crossing has been internally inspected under the DWR DMP Phase 1 project. Inspection report is still not available. (O. Magana - DWR UCIP)01/22/2014 Some sedimentation buildup at inlet and through pipe. (W. Wylie - DWR UCIP) FIELD_STRUCT_DESC: 24-inch corrugated metal drainage pipe through the levee, 12.5 feet below the crown. Flap gate on the waterside (WS) end. Concrete headwalls on both ends. (24-inch pipe [HLM 1.09] retained under Automatic Board Order (ABO) issued as Permit No. 11489, 1975 - Bank of Upper Lake). [Additional Reference(s): DWR Levee Log, 2005. USACE Sacramento O&M Manual 506.2, August 1961, (HLM 1.09), Station S60+40, 24-inch pipe, dwg no. CC-4-4-29, Index Sheet 4: page 4, 38 of 64]. FS Date: 10/24/2019 12:29:00 PM

Flapgate and headwall visible on WS toe.

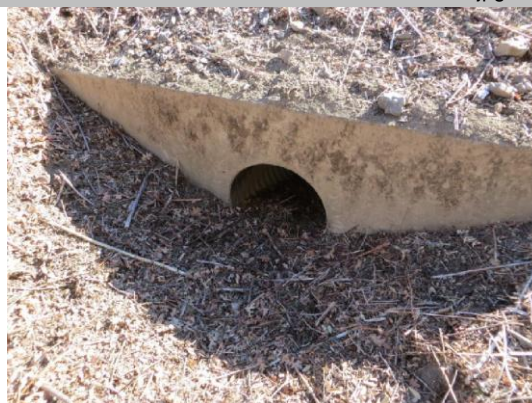
Photo 3 of 3 : UCIP_SP_2020_55785_51644.jpg

Concrete headwall on LS toe.

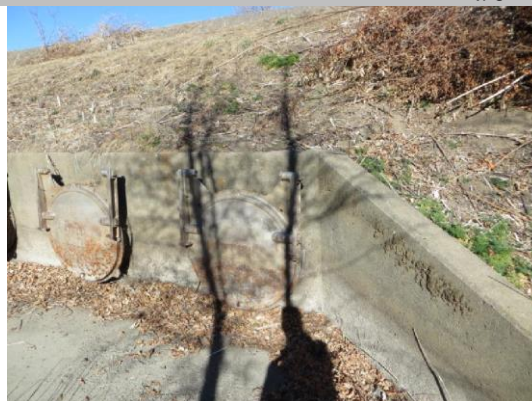
Photo 3 of 3 : UCIP_SP_2020_55786_51660.jpg

Flapgate on headwall at WS toe.

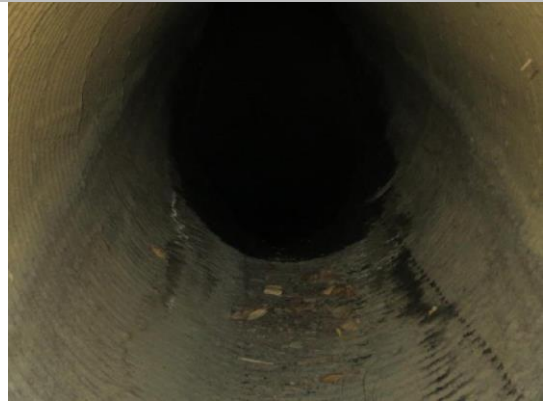
Photo 2 of 3 : UCIP_SP_2020_55787_51664.jpg

DS_ID:21237
 FS_ID:55787
 EP_NO: 11489
 Repair Type: Non-Urgent
 Crossing Status: Found
 UCIP Comments: 10/24/2019 Record has been updated from No Action needed to Non-Urgent; need to audit record to confirm owner. Crossing has been internally inspected under the DWR DMP Phase 1 project. Inspection report is still not available. (O. Magana - DWR UCIP)
 FIELD_STRUCT_DESC: 2 of 4: 36-inch corrugated metal drainage pipe through the levee, 15.2 feet below the crown. Flap gate on the waterside (WS) end. Concrete headwalls on both ends. (four 36-inch pipes [HLM 1.25] retained under Automatic Board Order (ABO) issued as Permit No. 11489, 1975 - Bank of Upper Lake). [Additional Reference(s): DWR Levee Log, 2005. USACE Sacramento O&M Manual 506.2, August 1961, (HLM 1.25), Station SA10+00, four 36-inch pipes, dwg no. CC-4-4-29, Index Sheet 4: page 4, 38 of 64 and Sheet 35.1 page 64 of 64].
 FS Date: 10/24/2019 12:30:00 PM

Pipe from LS toe.

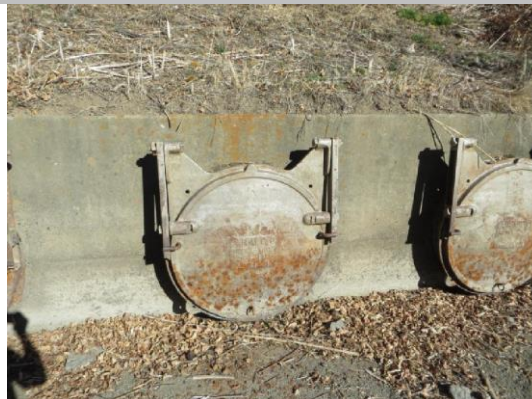
Photo 3 of 3 : UCIP_SP_2020_55788_51666.jpg

Flapgate on headwall at WS toe.

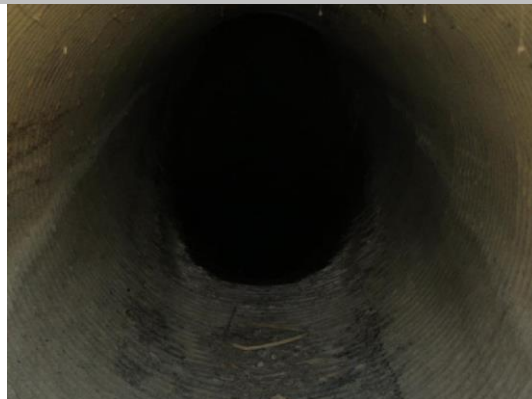
Photo 2 of 3 : UCIP_SP_2020_55789_51670.jpg

DS_ID:21239
FS_ID:55789
EP_NO: 11489
Repair Type: Non-Urgent
Crossing Status: Found
UCIP Comments: 10/24/2019 Record has been updated from No Action needed to Non-Urgent; need to audit record to confirm owner. Crossing has been internally inspected under the DWR DMP Phase 1 project. Inspection report is still not available.(O. Magana - DWR UCIP)
FIELD_STRUCT_DESC: 4 of 4: 36-inch corrugated metal drainage pipe through the levee, 15.2 feet below the crown. Flap gate on the waterside (WS) end. Concrete headwalls on both ends. (four 36-inch pipes [HLM 1.25] retained under Automatic Board Order (ABO) issued as Permit No. 11489, 1975 - Bank of Upper Lake). [Additional Reference(s): DWR Levee Log, 2005. USACE Sacramento O&M Manual 506.2, August 1961, (HLM 1.25), Station SA10+00, four 36-inch pipes, dwg no. CC-4-4-29, Index Sheet 4: page 4, 38 of 64 and Sheet 35.1 page 64 of 64].
FS Date: 10/24/2019 12:30:00 PM

Pipe from LS toe.

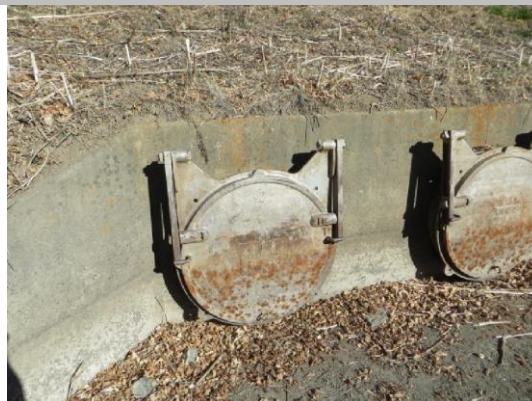
Photo 3 of 3 : UCIP_SP_2020_55789_51669.jpg

Flapgate on concrete headwall on WS toe.

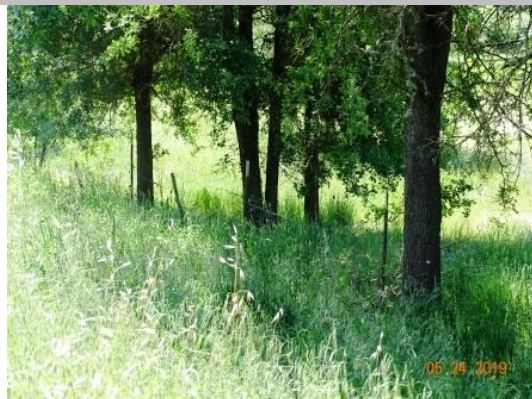
Photo 1 of 1 : SP_2020_NA0009_5_26_20200302_00006.jpg

LM Start	1.25	Rating **	M	Issue No.	26
LM End	1.34	Issue Type +	En	Location *	WS
Category	Earthen Levee			GPS Latitude/Longitude	
				Start	End
Item	Encroachments			39.160532 °	39.161265 °
				-122.926523 °	-122.927877 °
DWR ID	DWR_NA0009_03_s_2019_26				
Comment Code					
FE : Fence					
Inspector Comment					
The barbed wire fence along the waterside toe does not appear to be permitted.

View looking downstream at wire fence along the levee toe. Spring 2019

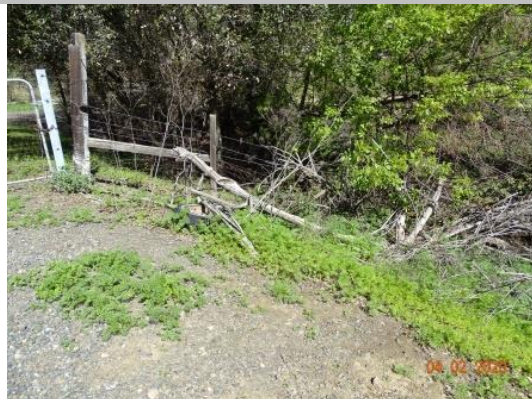
Photo 1 of 1 : SP_2020_NA0009_5_23_20200403_00052.jpg

LM Start	1.34	Rating **	M	Issue No.	23
LM End	1.34	Issue Type +	Ma	Location *	WS
Category	Earthen Levee			GPS Latitude/Longitude	
				Start	End
Item	Encroachments			39.161288 °	39.161288 °
				-122.927870 °	-122.927870 °
DWR ID	DWR_NA0009_03_s_2020_23				
Comment Code					
PR : Prunings					
Inspector Comment

View of prunings on the landside slope. Spring 2020

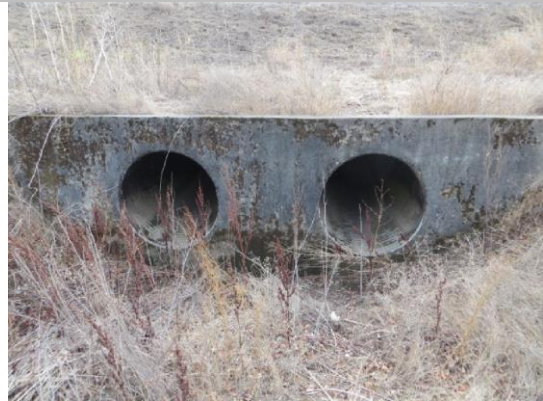
Photo 2 of 3 : UCIP_SP_2020_55812_49792.jpg

Comment Code					
Inspector Comment					
DS_ID:21236 FS_ID:55812 EP_NO: 11499 Repair Type: Non-Urgent Crossing Status: Found UCIP Comments: 10/16/2019 Record was updated from No Action Needed to Non-Urgent; need to audit record to confirm owner. Crossing has been internally inspected under the DWR DMP Phase 1 project. Inspection report is still not available. The UCIP inspection was completed with DWR Inspector, L. Dial, and LMA representative, S. Webb. (O. Magana - DWR UCIP) FIELD_STRUCT_DESC: 1 of 2: 42-inch corrugated metal drainage pipe through the levee, 12 feet below the crown. Flap gate on the waterside (WS) end. Concrete headwalls on both ends. (two 42-inch pipes [HLM 0.14] retained under Automatic Board Order (ABO) issued as Permit No. 11499, 1975 - Howard D. and Eunice A. Norton). [Additional Reference(s): DWR Levee Log, 2005. USACE Sacramento O&M Manual 506.2, August 1961, (HLM 0.14), Station DR8+60, two 42-inch pipes, dwg no. CC-4-4-29, Index Sheet 5: page 5, 39 of 64]. FS Date: 10/16/2019 4:01:00 PM

Concrete headwall visible on LS toe.

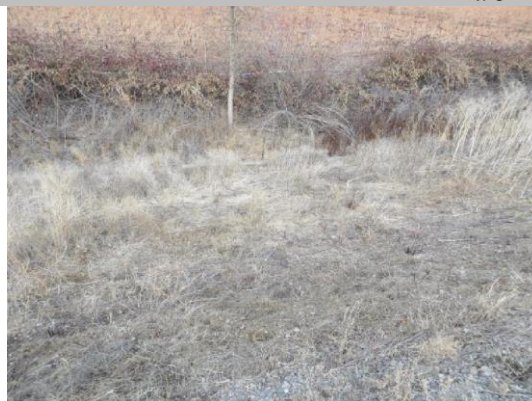
Photo 1 of 3 : UCIP_SP_2020_55813_49797.jpg

DS_ID:21225
FS_ID:55813
EP_NO: 11499
Repair Type: Non-Urgent
Crossing Status: Found
UCIP Comments: 10/16/2019 Record was updated from No Action Needed to Non-Urgent; need to audit record to confirm owner. Crossing has been internally inspected under the DWR DMP Phase 1 project. Inspection report is still not available. The UCIP inspection was completed with DWR Inspector, L. Dial, and LMA representative, S. Webb. (O. Magana - DWR UCIP)
FIELD_STRUCT_DESC: 2 of 2: 42-inch corrugated metal drainage pipe through the levee, 12 feet below the crown. Flap gate on the waterside (WS) end. Concrete headwalls on both ends. (two 42-inch pipes [HLM 0.14] retained under Automatic Board Order (ABO) issued as Permit No. 11499, 1975 - Howard D. and Eunice A. Norton). [Additional Reference(s): DWR Levee Log, 2005. USACE Sacramento O&M Manual 506.2, August 1961, (HLM 0.14), Station DR8+60, two 42-inch pipes, dwg no. CC-4-4-29, Index Sheet 5: page 5, 39 of 64].

Concrete headwall and inlet visible on LS toe.

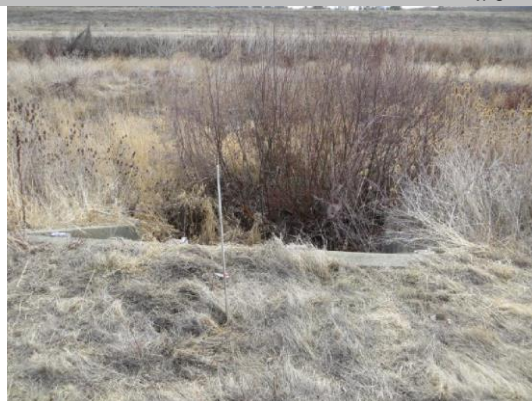
Photo 3 of 3 : UCIP_SP_2020_55813_49795.jpg

Concrete headwall visible on toe of WS berm.

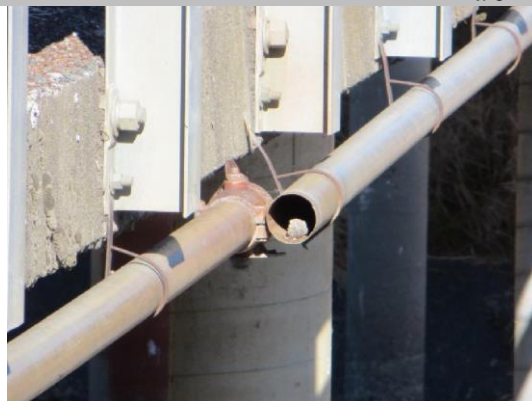
Photo 1 of 3 : UCIP_SP_2020_55814_49751.jpg

DS_ID:21226
FS_ID:55814
EP_NO: 6303A
Repair Type: Non-Urgent
Crossing Status: Found
UCIP Comments: 10/16/2019 Record remains Non-Urgent; crossing has been abandoned. Owner will need to coordinate with CVFPB to remove or abandon crossing per Title 23 requirements. The UCIP inspection was completed with DWR Inspector, L. Dial, and LMA representative, S. Webb. (O. Magana - DWR UCIP)01/09/2014 Pipe open on waterward side and should be plugged. (W. Wylie - DWR UCIP)
FIELD_STRUCT_DESC: 4-inch steel irrigation pipe through the levee, 1.5 feet below the crown. Steel cutoff wall around the pipe at center of levee. Pipe connects to 4-inch exposed aluminum pipe connected to upstream side of bridge. (4-inch water pipe authorized through both levees and suspended from the bridge authorized under Permit No. 6303-A, 1968 - John M. Siseuich). [Additional Reference(s): DWR Levee Log, 2005].
FS Date: 10/16/2019 4:02:00 PM

Pipe open on waterward end.

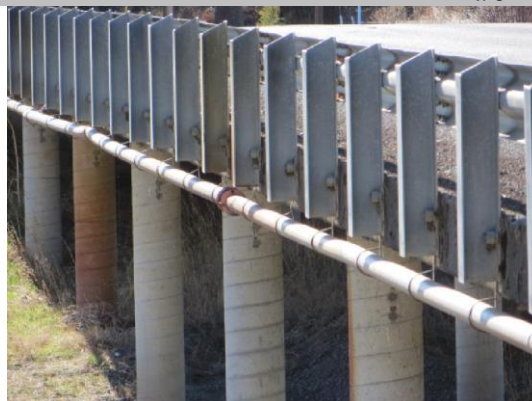
Photo 3 of 3 : UCIP_SP_2020_55814_49749.jpg

Pipe visible on upstream side of bridge.

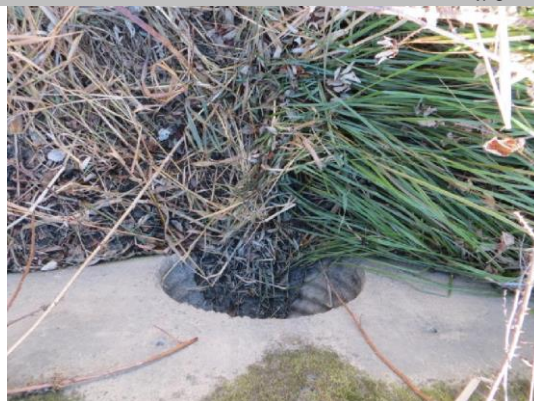
Photo 2 of 3 : UCIP_SP_2020_55811_49753.jpg

Pipe and concrete headwall visible in drainage channel on LS toe.

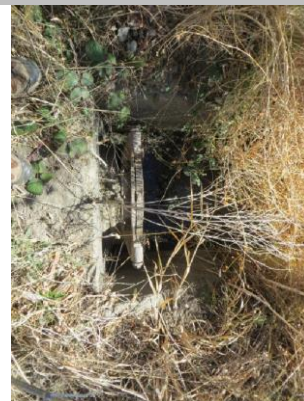
Photo 3 of 3 : UCIP_SP_2020_55811_49752.jpg

Flapgate at concrete headwall on WS toe.

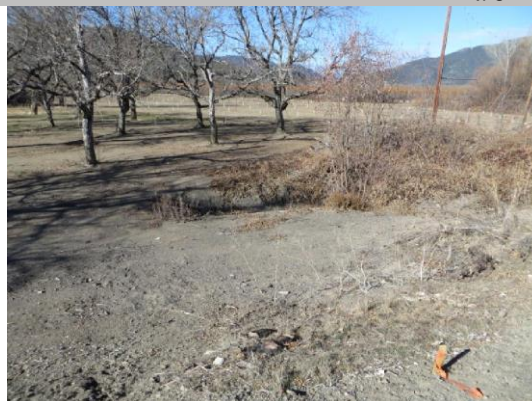
Photo 1 of 3 : UCIP_SP_2020_55816_49762.jpg

Drainpipe visible at LS toe.

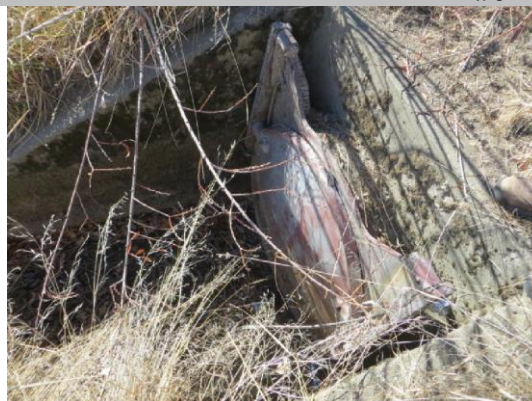
Photo 3 of 3 : UCIP_SP_2020_55816_49760.jpg

Concrete headwall visible off WS berm.

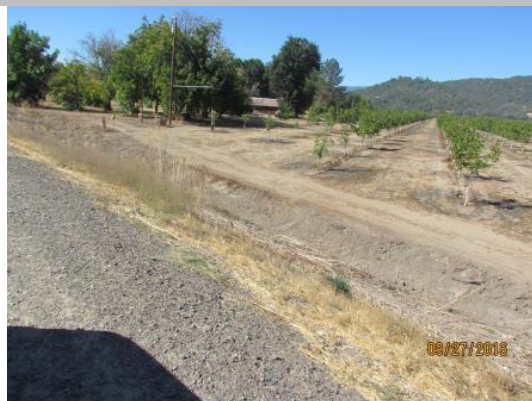
Photo 1 of 1 : SP_2020_NA0009_6_13_20200302_00006.jpg

LM Start	1.19	Rating **	M	Issue No.	13
LM End	1.25	Issue Type +	En	Location *	LS
Category	Earthen Levee			GPS Latitude/Longitude	
				Start	End
Item	Encroachments			39.182161 °	39.182862 °
				-122.894983 °	-122.894505 °
DWR ID	DWR_NA0009_04_f_2016_13				
Comment Code					
DT : Ditch					
Inspector Comment

View of a ditch at the landside toe looking downstream. Spring 2016

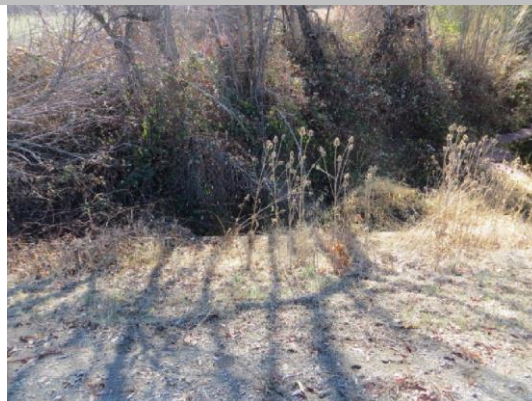
Photo 2 of 3 : UCIP_SP_2020_55848_49711.jpg

Outlet visible at concrete headwall on LS toe.

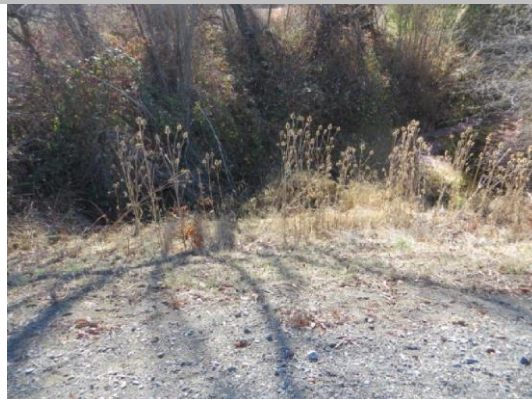
Photo 2 of 3 : UCIP_SP_2020_55849_49681.jpg

Outlet visible at concrete headwall on LS toe.

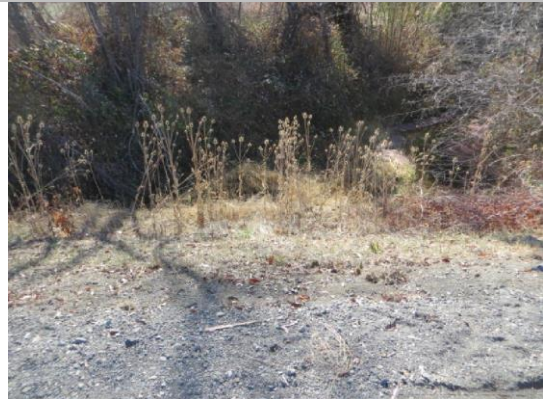
Photo 2 of 3 : UCIP_SP_2020_55853_49665.jpg

Outlet visible at concrete headwall on LS toe.

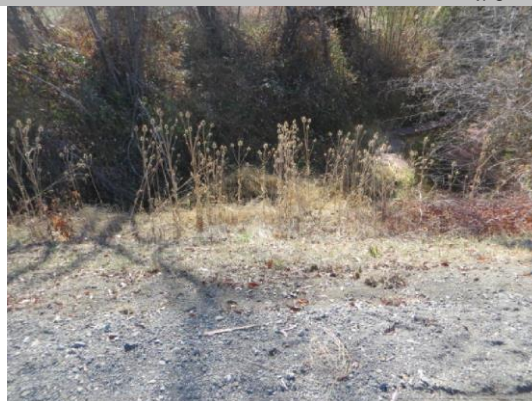
Photo 2 of 3 : UCIP_SP_2020_55851_49633.jpg

LM Start	0.32	Rating **	M	Issue No.	27 (cont)
LM End	0.32	Issue Type +	Ma	Location *	
Category	Supplemental		GPS Latitude/Longitude		
			Start	End	
Item	DWR UCIP LMA Responsibility		39.177074 °	39.177074 °	
			-122.898949 °	-122.898949 °	
DWR ID	21232

Outlet visible at concrete headwall on LS toe.

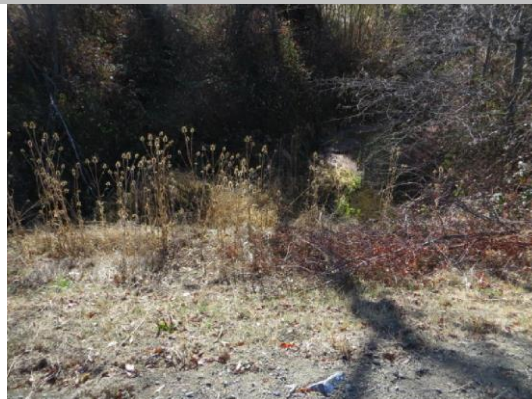
Photo 2 of 3 : UCIP_SP_2020_55854_49621.jpg

LM Start	0.32	Rating **	M	Issue No.	28 (cont)
LM End	0.32	Issue Type +	Ma	Location *	
Category	Supplemental		GPS Latitude/Longitude		
			Start	End	
Item	DWR UCIP LMA Responsibility		39.177070 °	39.177070 °	
			-122.898967 °	-122.898967 °	
DWR ID	21231

Pipe visible at concrete headwall on LS toe.

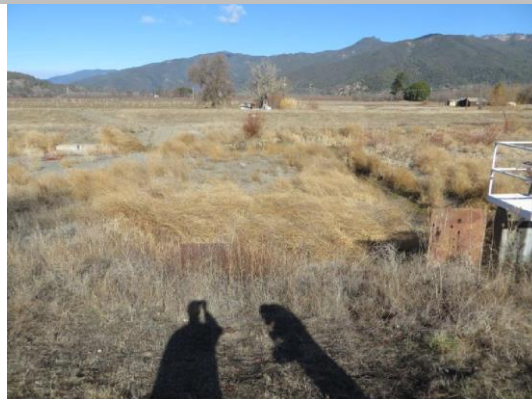
Photo 1 of 3 : UCIP_SP_2020_55341_49610.jpg

Comment Code					
Inspector Comment					
DS_ID:21229 FS_ID:55341 EP_NO: 11507 Repair Type: Non-Urgent Crossing Status: Found UCIP Comments: 10/16/2019 (O. Magana - DWR UCIP)10/27/2017 This structure is inspected annually under the Structure and Channel Summer Inspection (part of the Levee Inspection Program) conducted by the DWR Flood Project Integrity and Inspection Branch (FPIIB). (DWR UCIP - O. Magana) 01/09/2014 Some sediment buildup at outlet on LS toe. (W. Wylie - DWR UCIP) FIELD_STRUCT_DESC: [Clover Creek Diversion Structure] 6 of 6: 36-inch corrugated metal drainage pipe through the levee, 12 feet below the crown. Concrete headwall on both ends. Steel slide gate covers waterside (WS) inlet. (six 36-inch pipes and structure [HLM 0.3] retained under Automatic Board Order (ABO) issued as Permit No. 11507, 1975 - Lake County Flood Control and Water Conservation District). [Additional Reference(s): DWR Levee Log, 2005. USACE Sacramento O&M Manual 506, Part 2, August 1961, (HLM 0.31)]. FS Date: 10/16/2019 4:06:57 PM

Steel slide gate visible at headwall on WS toe.

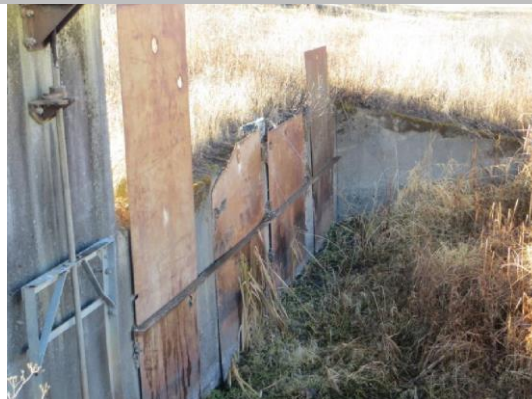
Photo 3 of 3 : UCIP_SP_2020_55341_49608.jpg

LM Start	0.32	Rating **	M	Issue No.	29 (cont)
LM End	0.32	Issue Type +	Ma	Location *	
Category	Supplemental		GPS Latitude/Longitude		
			Start	End	
Item	DWR UCIP LMA Responsibility		39.177066 °	39.177066 °	
			-122.898986 °	-122.898986 °	
DWR ID	21229

Steel slide gate visible at headwall on WS toe.

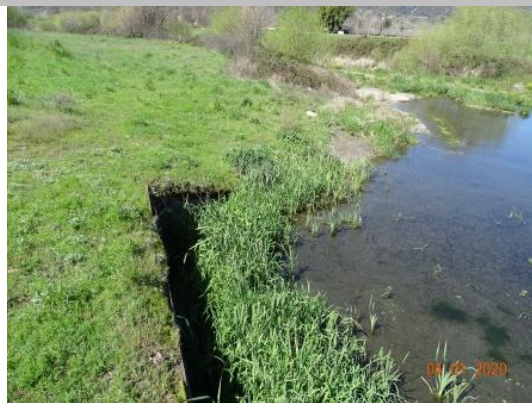
Photo 1 of 1 : SP_2020_NA0009_7_13_20200403_00042.jpg

LM Start	0.32	Rating **	A/W	Issue No.	13
LM End	0.32	Issue Type +	Ma	Location *	WS
Category	Earthen Levee			GPS Latitude/Longitude	
				Start	End
Item	Erosion / Bank Caving			39.177150 °	39.177150 °
				-122.899111 °	-122.899111 °
DWR ID	LCWPD-01				
Comment Code					
E1 : Note and monitor erosion site.					
Inspector Comment					
Site ID No:19					
Site Designation:LCWPD-01					
Grass and wild growth have covered the erosion on the left bank.

View of erosion of the left bank downstream of the diversion structure.
Spring 2020

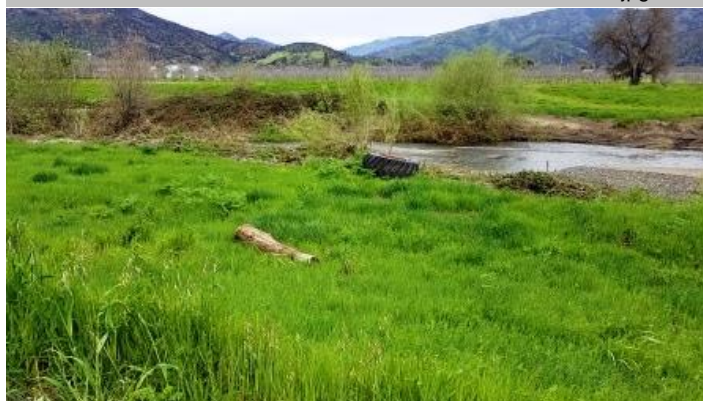
Photo 1 of 1 : SP_2020_NA0009_7_17_20200302_00007.jpg

LM Start	0.33	Rating **	M	Issue No.	17
LM End	0.33	Issue Type +	Ma	Location *	WS
Category	Earthen Levee			GPS Latitude/Longitude	
				Start	End
Item	Encroachments			39.176973 °	39.176973 °
				-122.899228 °	-122.899228 °
DWR ID	DWR_NA0009_05_s_2019_17				
Comment Code					
DE : Debris					
Inspector Comment					
Remove a large tire in the waterway.

View of large tire and tree log in the waterway. Spring 2019

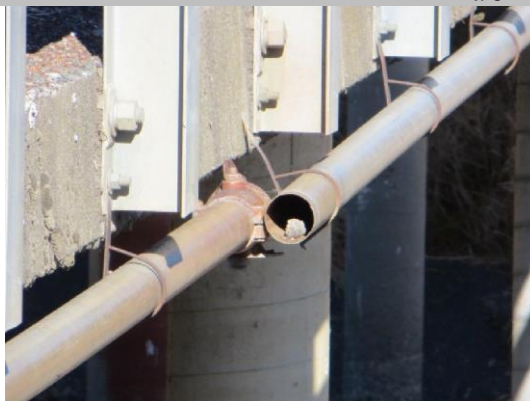
Photo 2 of 3 : UCIP_SP_2020_55818_49592.jpg

Comment Code					
Inspector Comment					
DS_ID:21230 FS_ID:55818 EP_NO: 6303A Repair Type: Non-Urgent Crossing Status: Found UCIP Comments: 10/16/2019 Record remains Non-Urgent; crossing has been abandoned. Owner will need to coordinate with CVFPB to remove or abandon crossing per Title 23 requirements. The UCIP inspection was completed with DWR Inspector, L. Dial, and LMA representative, S. Webb. (O. Magana - DWR UCIP)01/09/2014 Pipe plugged on WS near bridge centerline. (W. Wylie - DWR UCIP) FIELD_STRUCT_DESC: 4-inch steel irrigation pipe through the levee, 1.5 feet below the crown. Steel cutoff wall around pipe at center of levee. Pipe connects to 4-inch exposed aluminum pipe visible on upstream side of bridge. (4-inch water pipe authorized through both levees and suspended from the bridge authorized under Permit No. 6303-A, 1968 - John M. Siseuich). [Additional Reference(s): DWR Levee Log, 2005]. FS Date: 10/16/2019 4:07:00 PM

Aluminum irrigation pipe visible on upstream side of bridge.

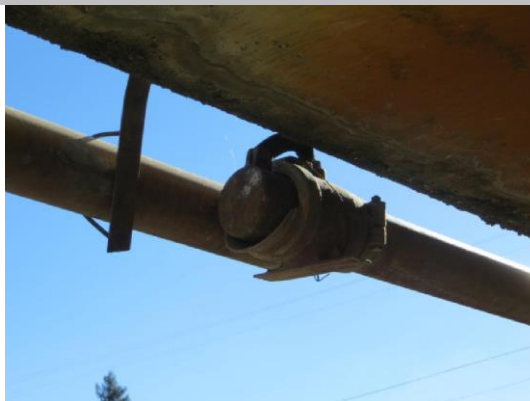
Photo 3 of 3 : UCIP_SP_2020_55818_49591.jpg

Aluminum pipe plugged near center of bridge.

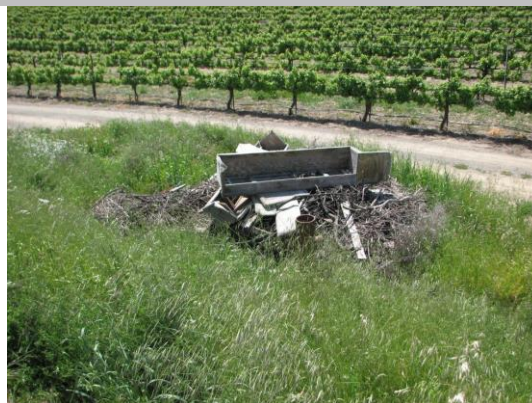
Photo 1 of 1 : SP_2020_NA0009_7_10_20200302_00001.jpg

LM Start	0.63	Rating **	M	Issue No.	10
LM End	0.63	Issue Type +	En	Location *	LS
Category	Earthen Levee			GPS Latitude/Longitude	
				Start	End
Item	Encroachments			39.175758 °	39.175758 °
				-122.904353 °	-122.904353 °
DWR ID	DWR_NA0009_05_s_2016_10				
Comment Code					
DE : Debris					
Inspector Comment					
Remove prunings and lumber debris.

5/2/2016: Remove prunings and lumber debris from L/S toe.

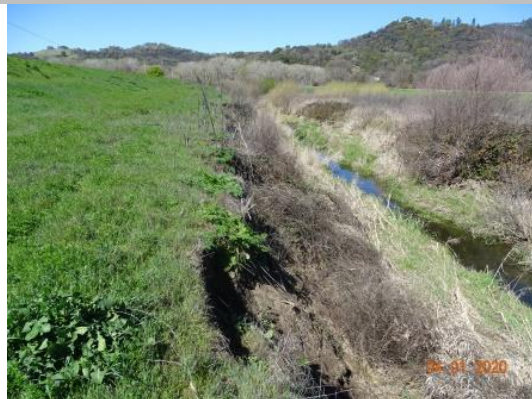
Photo 1 of 1 : SP_2020_NA0009_7_20_20200403_00035.jpg

LM Start	0.82	Rating **	U	Issue No.	20
LM End	0.86	Issue Type +	Ma	Location *	WS
Category	Earthen Levee			GPS Latitude/Longitude	
				Start	End
Item	Erosion / Bank Caving			39.175740 °	39.175750 °
				-122.907980 °	-122.908710 °
DWR ID	LCWPD-02				
Comment Code					
E1 : Note and monitor erosion site.					
Inspector Comment					
Levee Evaluation Comments					
Description:					
Site ID No:20					
Site Designation:LCWPD-02					
Notes: 5 - 7 ft deep erosion scarps, bank is normally near vertical but at a much smaller drop off, 1 - 3 ft. Erosion widened the creek downstream. The erosion might be past 20-30' from the levee toe.

View of erosion of the waterside bank looking downstream. Spring 2020
